## 5 INFLIGHT SCIENCE AND PHOTOGRAPHY

The inflight experiments and photographic tasks conducted during the Apollo 15 mission are discussed in this section. The discussion is concerned primarily with experiment hardware performance and data acquisition operations. In instances where preliminary scientific findings were available at the time of report preparation, they are included, but more complete information on scientific results will be found in reference 2.

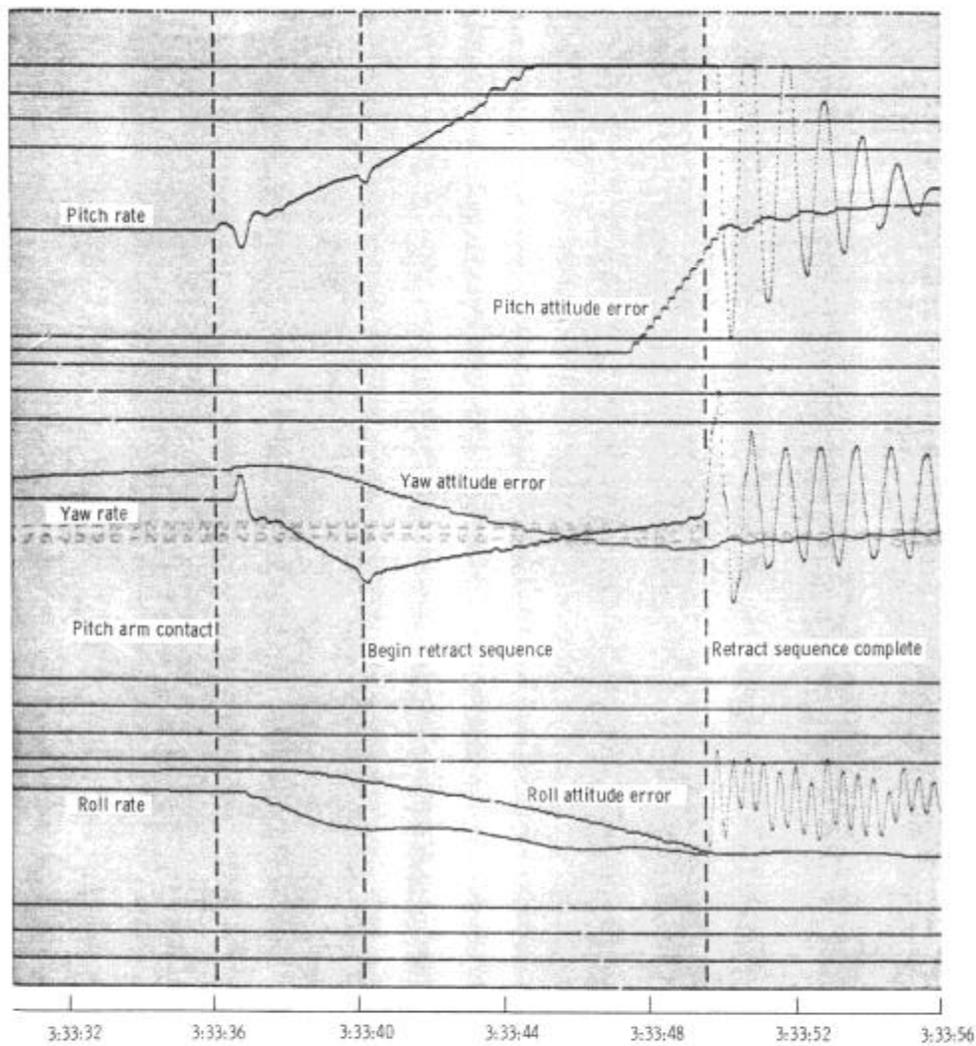
Figure 6-1. - Rate and attitude error data during transposition and docking sequence,

docking sequence, the digital autopilot control mode was changed from "attitude hold" to "free" while a plus-X translation was being commanded in order to secure a positive capture latch indication. The body rates induced by contact and the plus-X thrusting were not nulled and resulted in misalignment angles of minus 1-1.0, plus 2.2, and plus 1.6 degrees in pitch, yaw and roll at the start of the retract sequence (see fig. 6-1). The resultant misalignment caused a greater-than-normal structural loading in the docking interface (see sec. 7.1).

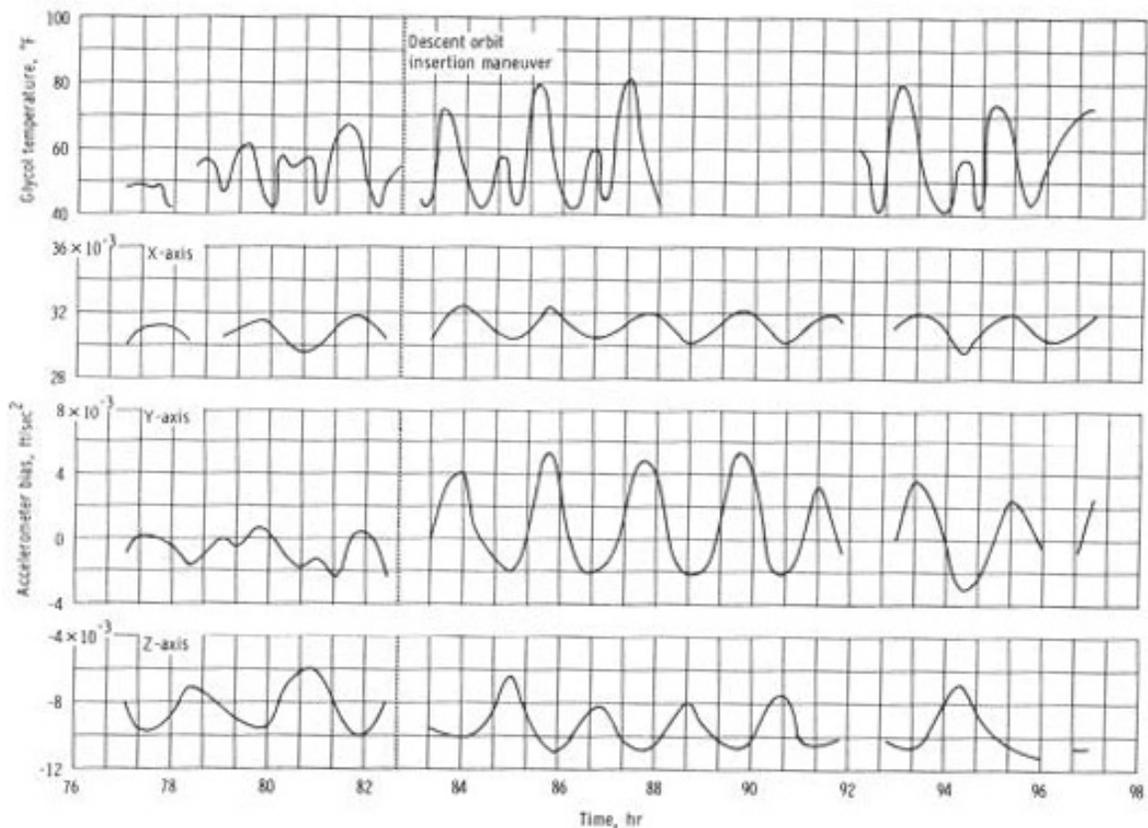
Figure 6-2.- Effect of coolant temperature oscillations on accelerometer bias during lunar orbit.

During lunar orbital operations between 84 and 95 hours , the command and service module maintained a period of local horizontal attitude hold with the scientific instrument module toward the lunar surface. The evaporator in the primary coolant loop was turned off to prevent interference with the inflight science activities. The resulting large temperature oscillations in the coolant loop gave some concern as to how these temperature excursions would affect the guidance equipment. Since no direct guidance equipment telemetry measurements of coolant temperatures were available, an analysis was performed using a thermal model of the coolant loop and a ground test was performed with non-flight guidance equipment. Both indicated that considerable temperature attenuation exists in the coolant loop and that temperatures experienced during the flight were within acceptable limits. As a result of the thermal analysis, the maximum temperature limits in the systems operational data book are being raised to 90 F, peak, and 75 F, average, over a 2-hour period. The effect of coolant temperature oscillations upon accelerometer bias is shown in **Figure 6-2**.

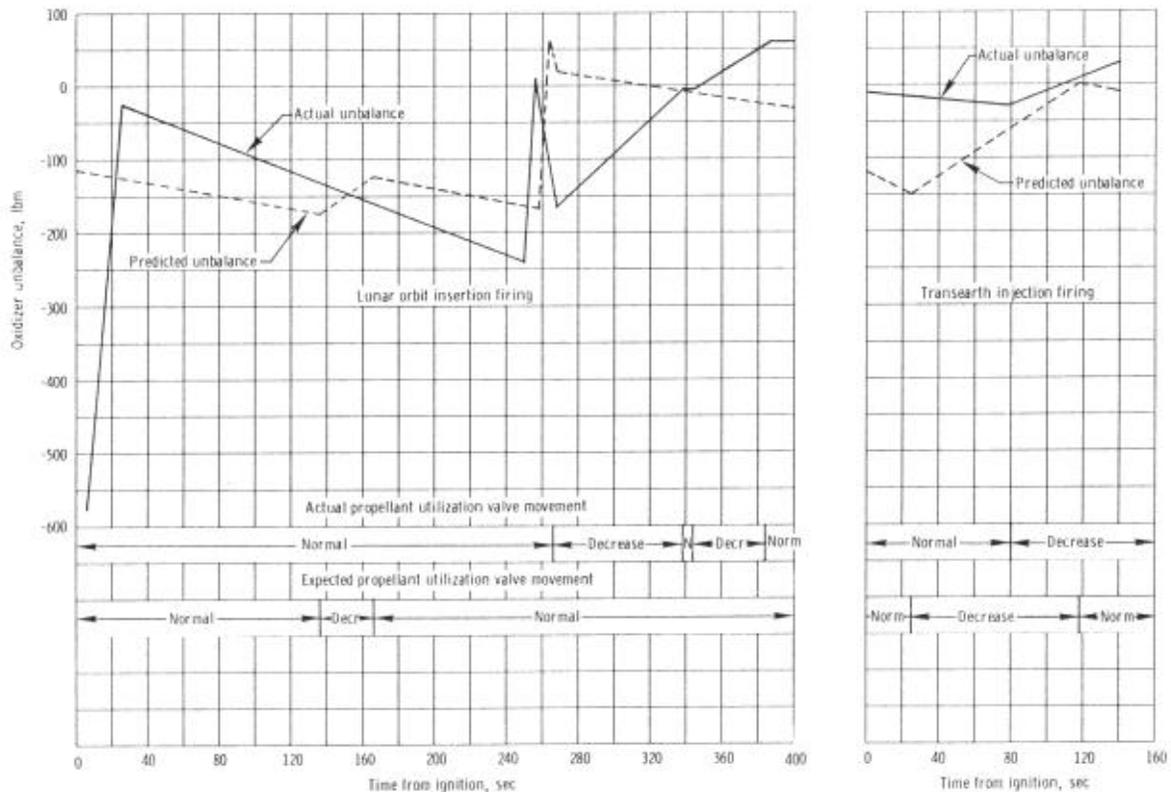
Figure 6-3.- Propellant unbalance during the lunar orbit insertion and transearth injection firings.

Previous flight results have shown the inflight mixture ratio to be significantly less than expected from engine acceptance test data. The service propulsion system engine was re-orificed to increase the mixture ratio for this mission. **Figure 6-3** shows the propellant unbalance for the two major engine firings compared with the predicted unbalance. The unbalance at the end of the transearth injection firing was very small and shows that the modifications to the engine were satisfactory.
